**SMITTY'S CATFISH POND DAM
MADISON COUNTY, MISSOURI
MO 30613**

**PHASE 1 INSPECTION REPORT
NATIONAL DAM SAFETY INSPECTION**

APRIL 1981

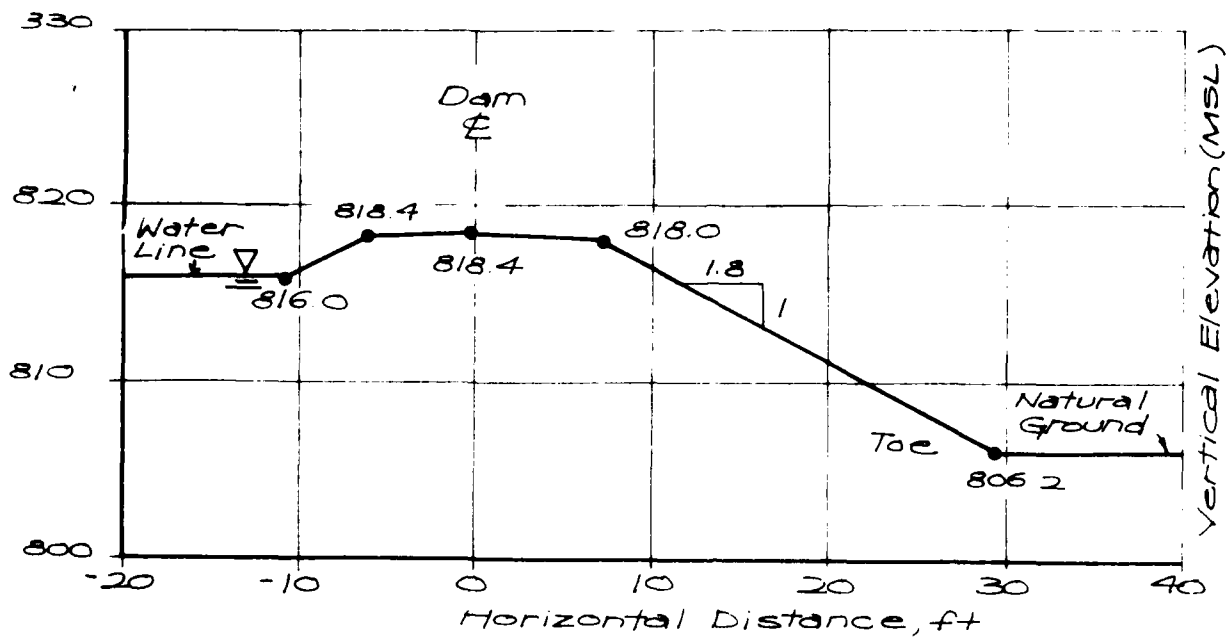
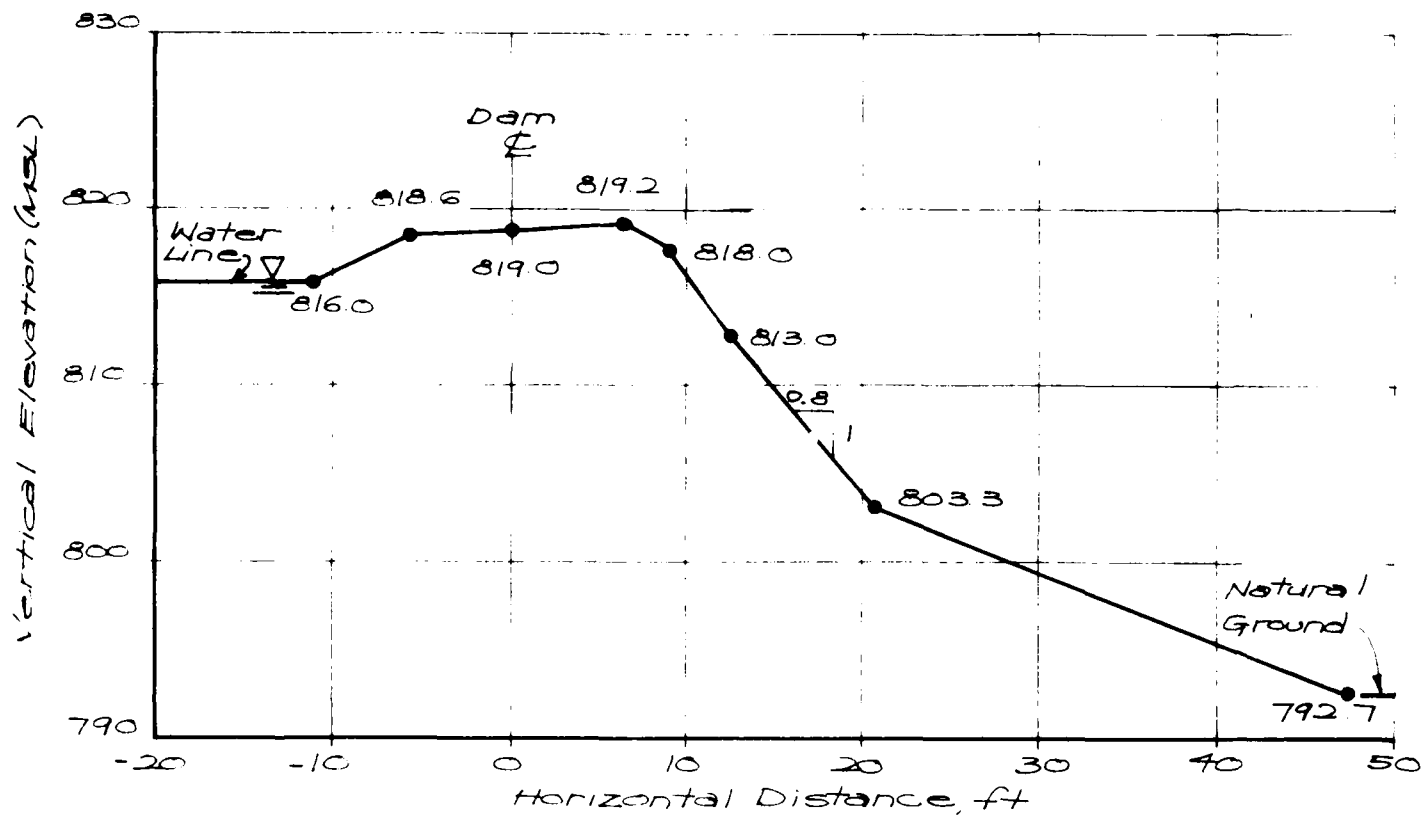
Fig. 3-B

The downstream slope is steep (Fig. 3B), typically 1.8(H) to 1(V), but locally the slopes are steeper than 1(H) to 1(V). As a result of the steep slopes and the embankment materials, the dam is judged to be moderately to highly erodible in the event of overtopping.
